DELAWARE RIVER BASIN
HAYNES CREEK TRIBUTARY
BURLINGTON COUNTY
NEW JERSEY

MISHE - MOKWA DAM
NJ 00419

PHASE 1 INSPECTION REPORT
NATIONAL DAM SAFETY PROGRAM

May 79 1979

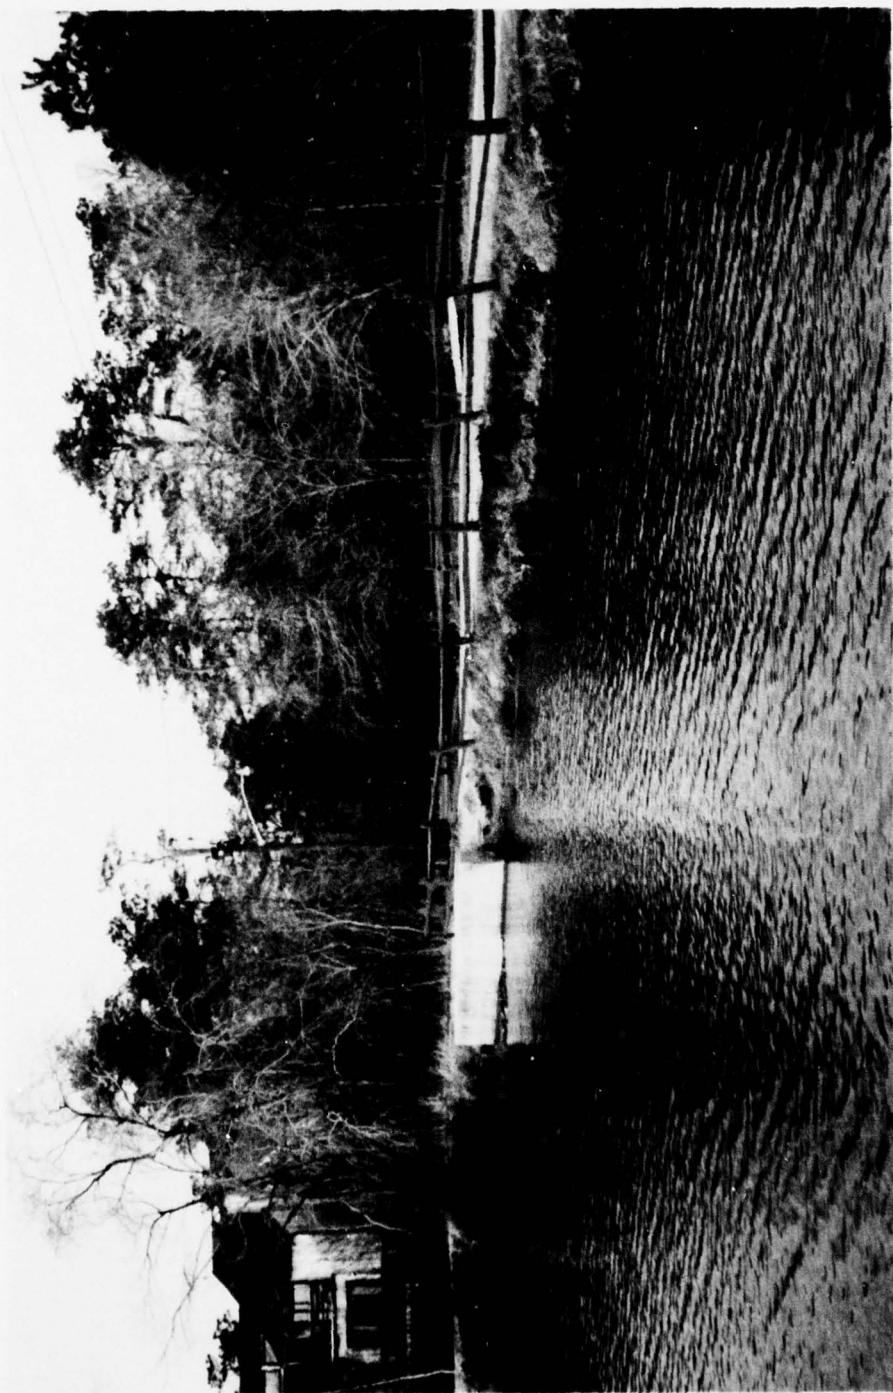
OVERVIEW - MISHE - MOKWA DAM

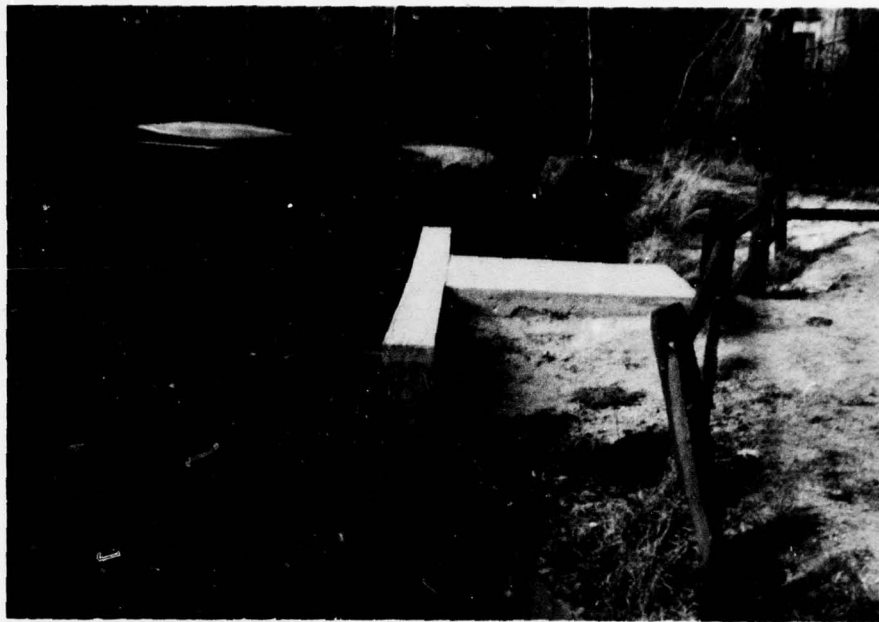
The crest of the spillway appeared uniformly aligned although a major part of it was submerged by overflow at the time of inspection. Water was flowing over the concrete weir section of the spillway and, therefore, the condition of much of the structure was not clearly observed. In general, the concrete as well as the steel grate and timber stoplogs appeared to be in good condition.

PHOTO 1
SPILLWAY

The spillway appears to be in good condition. However, in the near future, it should be thoroughly inspected and renovated by sand blasting, grouting where needed and coating with epoxy.

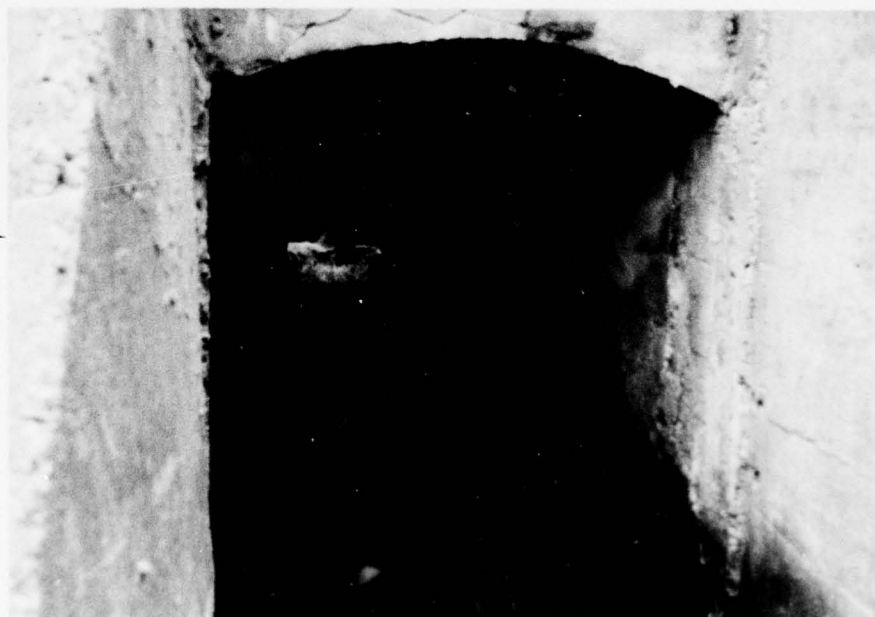
PHOTO 4

SPILLWAY DISCHARGE CULVERT.

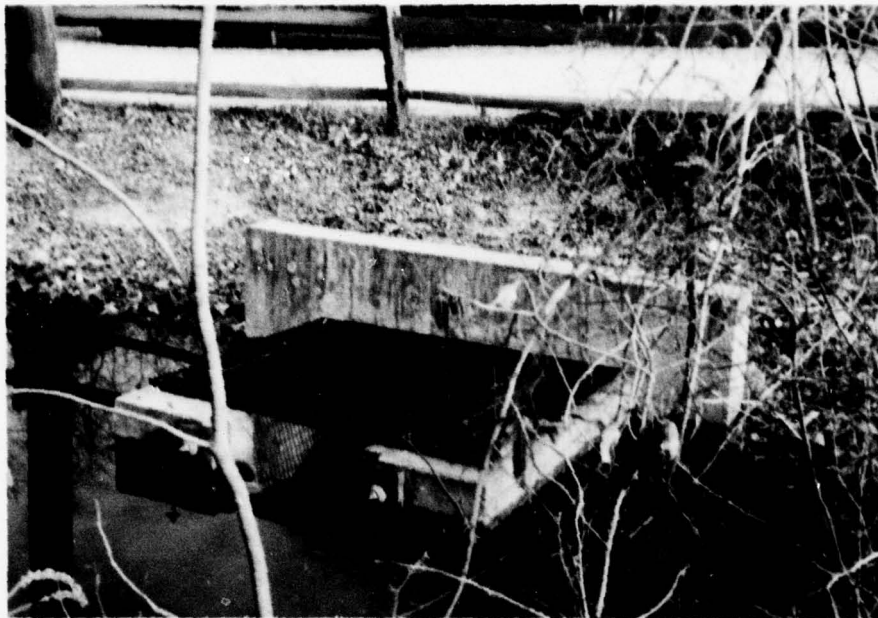
PHOTO 5

DISCHARGE STRUCTURE FOR BYPASS CHANNEL.

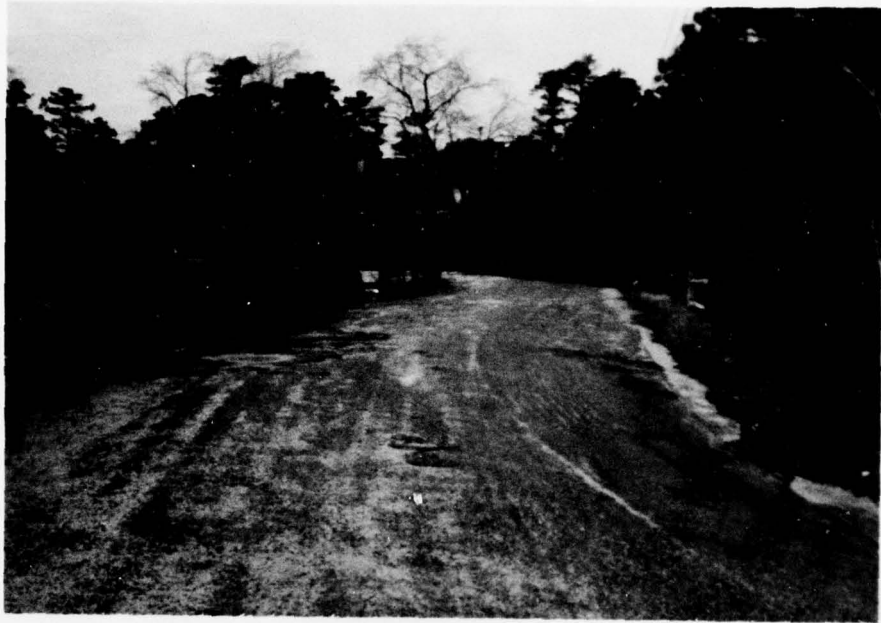
The dam embankment crest appeared to be level, with a slightly curved horizontal alignment. A paved road lies on the crest and was found to be in good condition.

PHOTO 9
ROAD ON CREST OF DAM.
